LEGISLATION.

ALTERATIONS IN INSTRUMENTS AND ESTABLISHMENT.

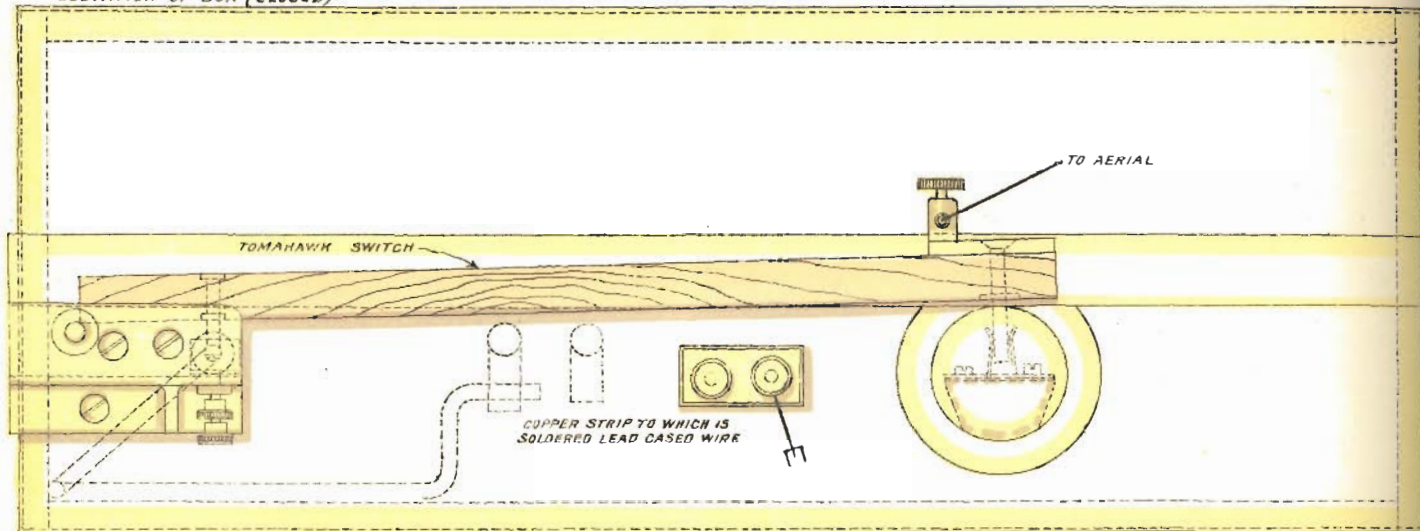
BOX SCREENING (PATT. 1779)

ELEVATION OF BOX (CLOSED)

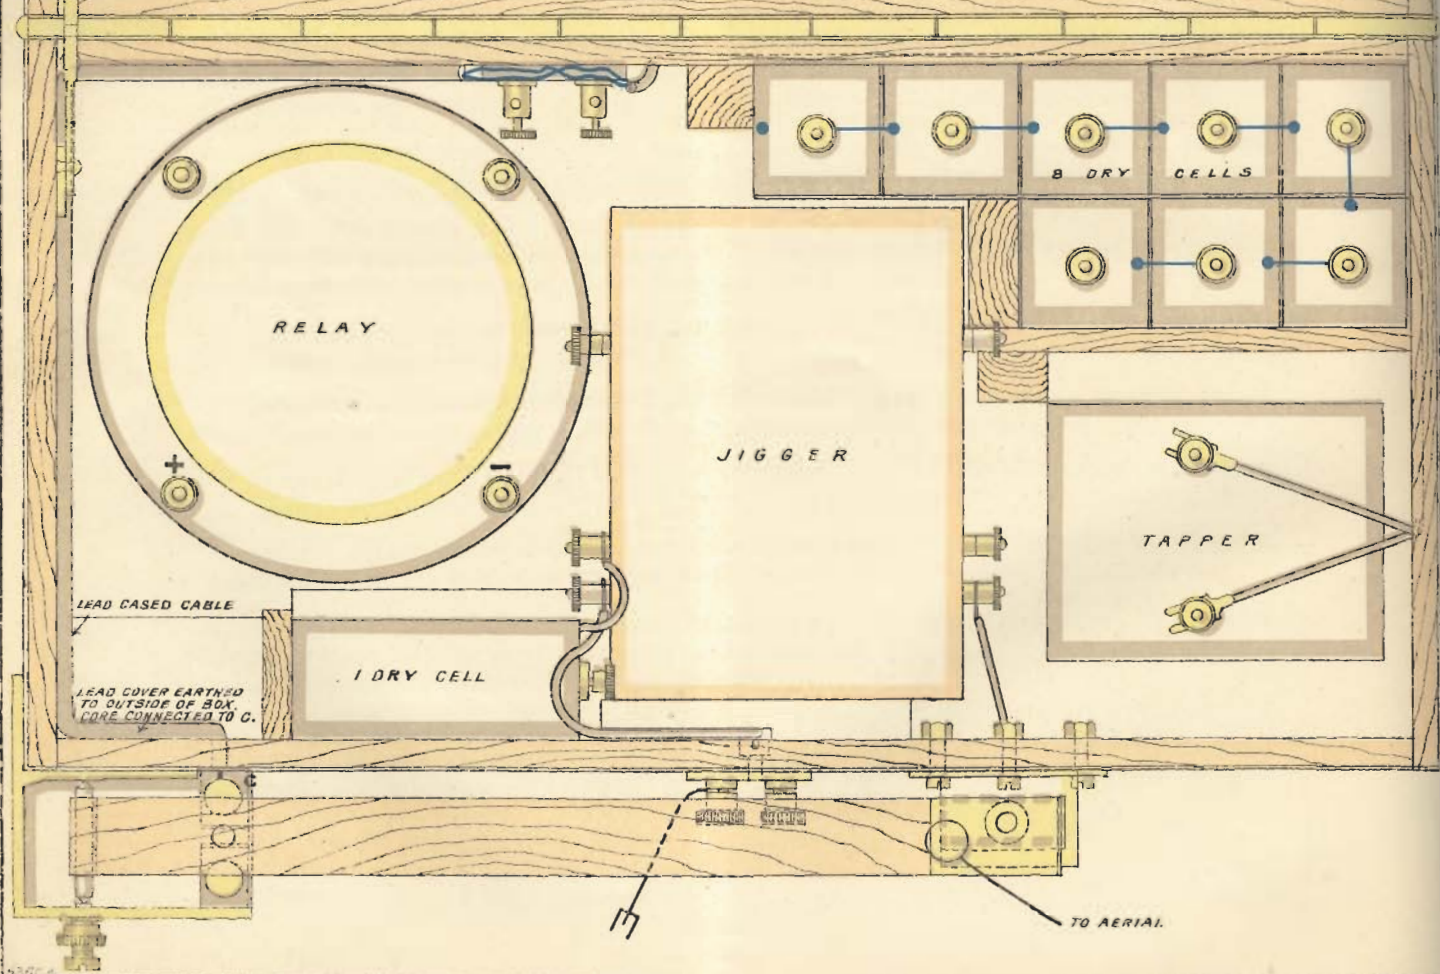
PLAN OF BOX WITH LID OPEN (SHOWING CONNECTIONS SUPPLIED WITH BOX.)

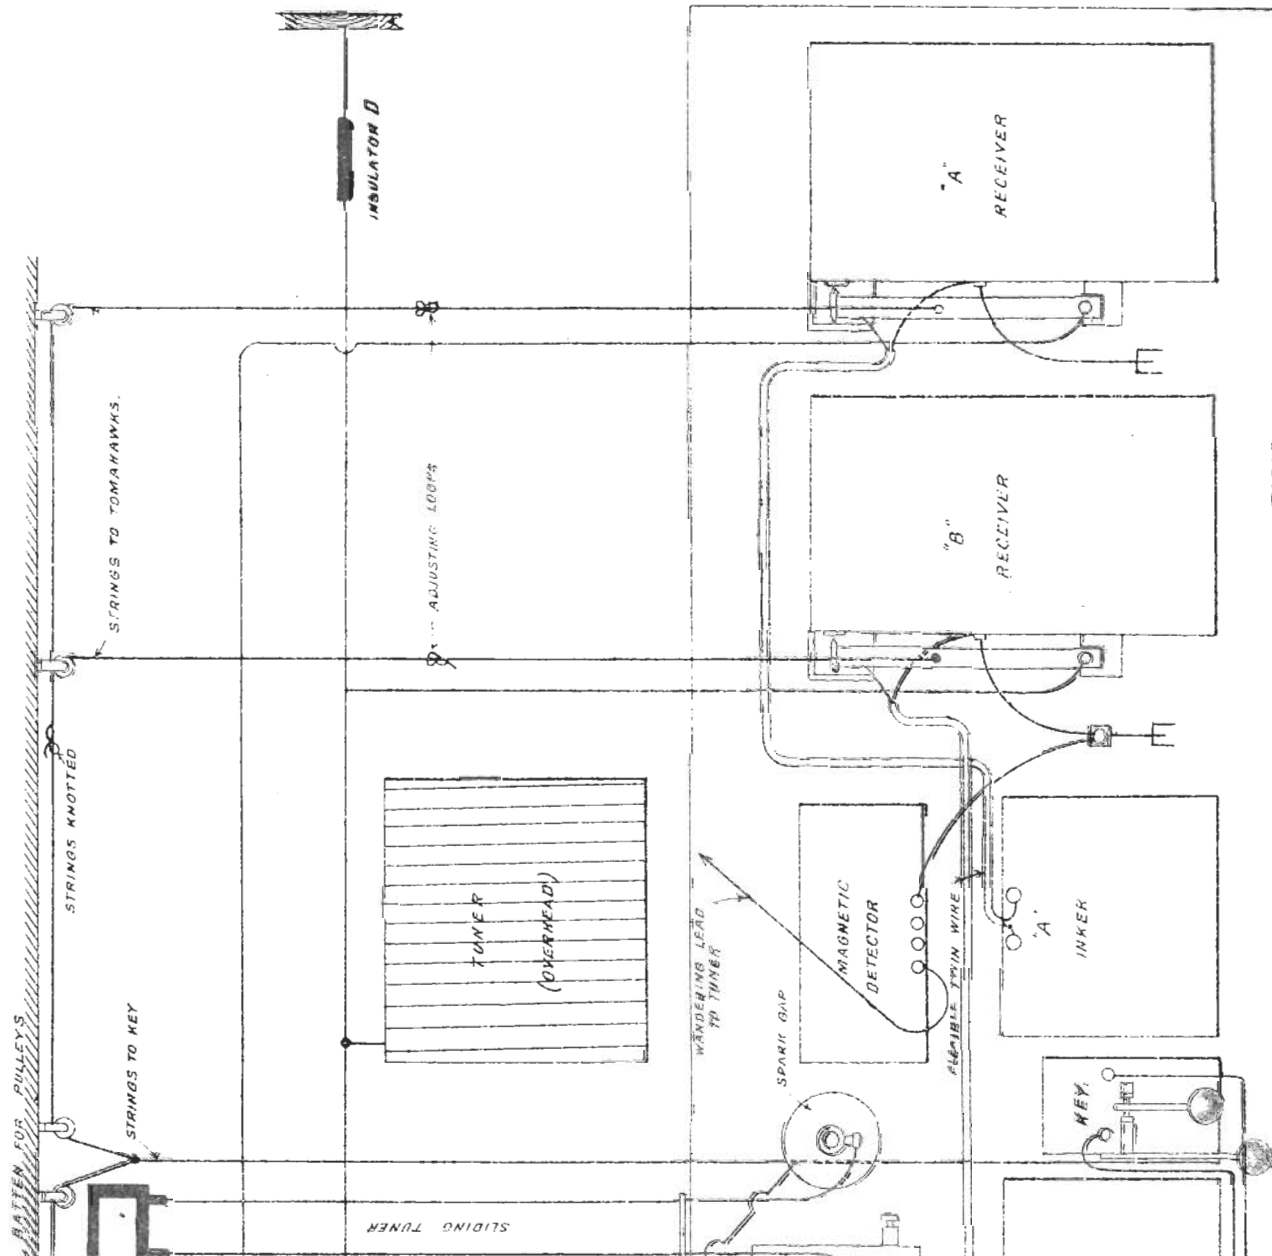
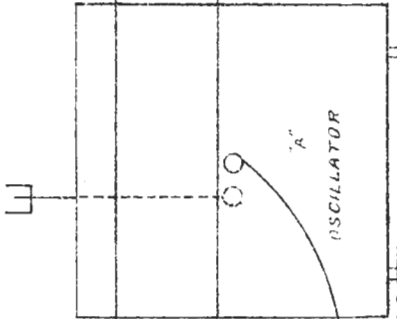
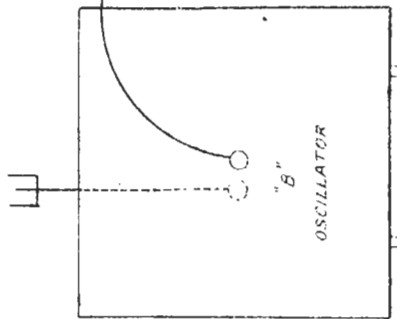
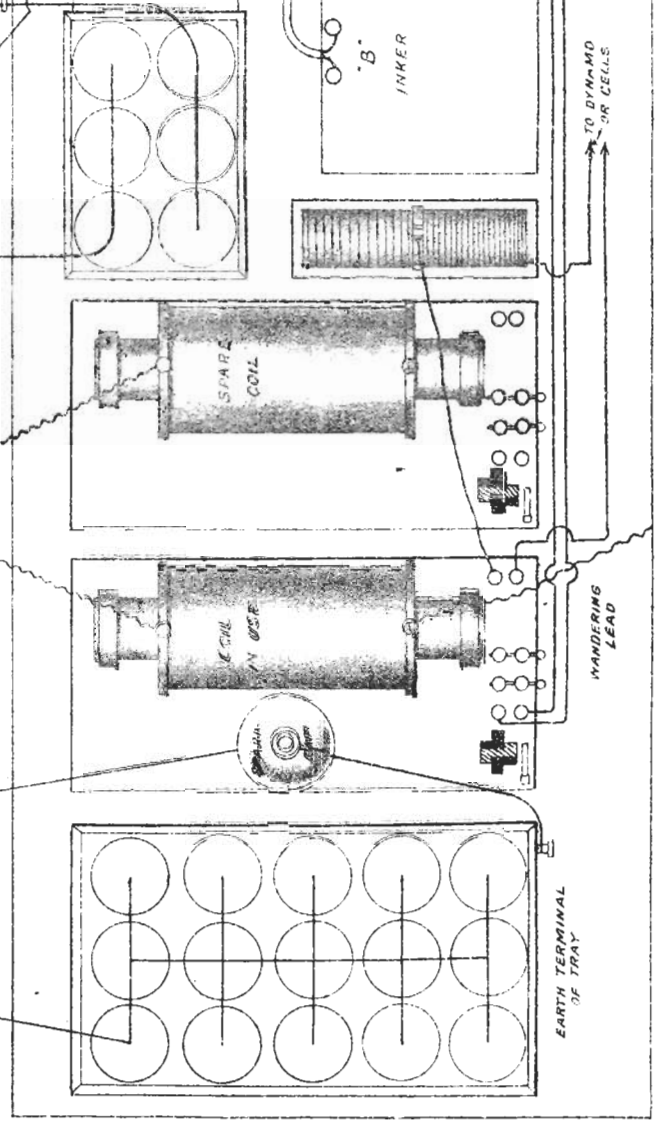
W.T. INSTALLATION / 04

Note.—The following differences will be observed between this plate and that accompanying A.L. 6.1.05:--

- (i) The lead from the Sliding Tuner goes direct to the three jars nearer to the inker. There is no lead to the box terminal at all.
- (ii) The plugs connecting up the condensers of both coils are pushed home.
- (iii) The horizontal part of the receiving Aerial for "A" tune is stayed in a similar manner to that for "B" tune.

TO DOUBLE CONVANTAL THROUGH DECK TUBE

ADJUSTING LOOP

vertically as possible, consistent with their not being within 6 feet of ironwork or stays for any considerable length. The upper ends may, if necessary, be lead forward or aft as convenient, if too long for the mast.
